Aviation Occurrence Investigation AO-2008-053

Preliminary

**Depressurisation
475 km north-west of Manila, Philippines
25 July 2008
Boeing Company 747-438, VH-OJK**

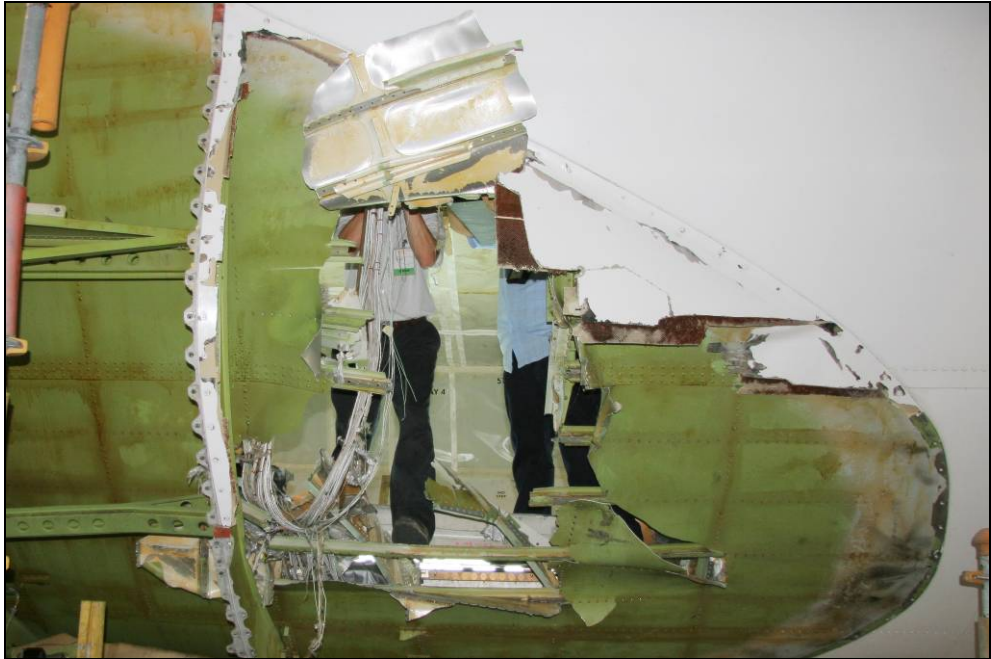
square inches). Figure 3 illustrates the extent of the fuselage rupture as viewed from outside the aircraft.

Figure 3: Extent of the fuselage rupture, after removal of further transition fairings

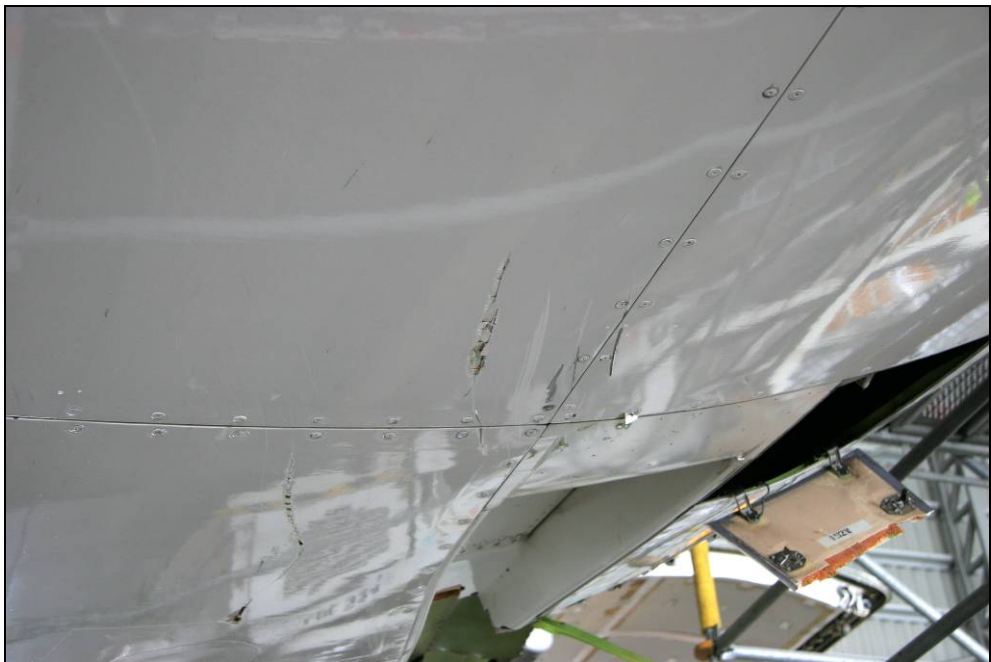
Rearward of the fuselage rupture, several localised areas of scuffing, puncture and scoring were evident along the underside of the aircraft, extending along a diagonal path from the ruptured area rearward toward the left body landing gear (Figure 4). Elongated score marks were also noted extending for several metres around the left side of the rear fuselage – typically around STA 1880 to STA 2000.

Figure 4. Panel damage to the rear of the rupture site

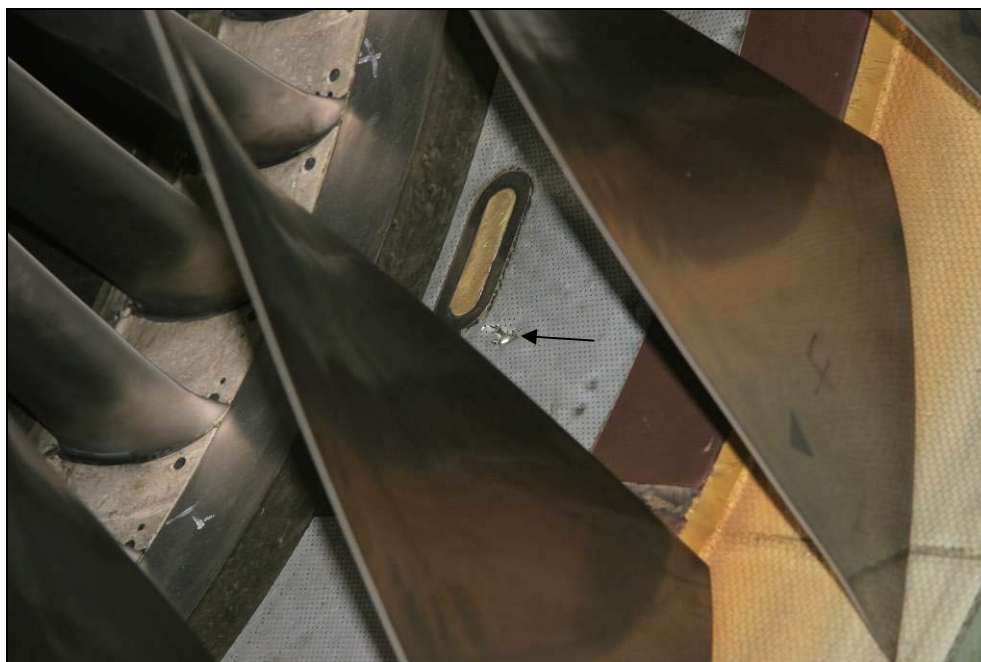
Several small pieces of structural honeycomb material of the type comprising the wing leading edge fairing were found trapped around the edges of panels within the left side of the number-3 engine pylon (side facing the rupture). A small indentation and cut was found within the number-3 engine intake acoustic panelling, located immediately inside the plane of rotation of the engine fan (Figure 5). There was no

evidence of damage to the fan blades themselves, nor was there any evidence of the ingestion of debris into the engine core.

Figure 5: Damage to acoustic lining (arrowed) behind the number-3 engine fan

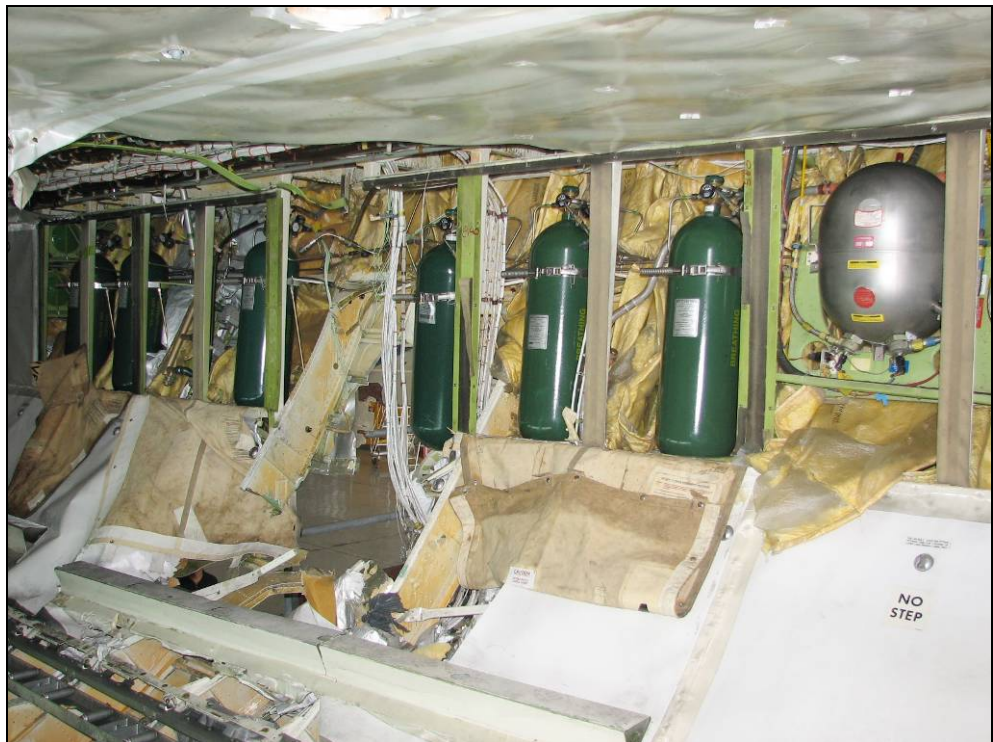
Figure 6: Forward cargo hold wall with remaining six oxygen cylinders

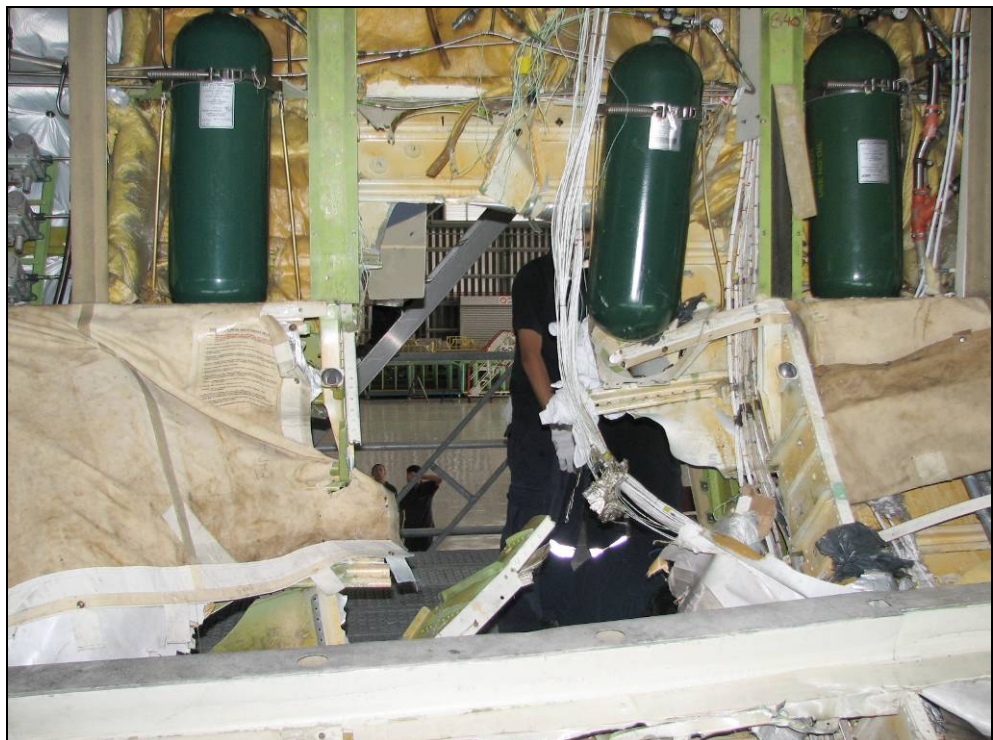
Following removal of all cargo materials and lowering of the hold right-side curtain panels, it was found that the fuselage rupture was aligned with the nominal position of the number-47 passenger emergency oxygen cylinder; one of seven such cylinders in a bank along the right side of the hold (Figure 6). A further six cylinders were located in a central location within the ceiling of the cargo hold. The number-4 cylinder was missing from the bank, with the upper support bracket bent downward and both the retaining strap and lower cradle not present (Figure 7). The adjacent number-5 cylinder lower support cradle had been pulled downward and away from the cylinder as a result of the fuselage rupture. However, the upper cylinder mount and strapping remained secure and the cylinder gas connections intact. Each of the passenger oxygen cylinders had three connected stainless steel lines – an overpressure relief vent line, a delivery line and a filling line. The filling and delivery lines were fed through a tee-piece from a common cylinder connection, with a pressure regulator and transducer integral to the assembly (Figure 8). All three lines to the missing number-4 cylinder had fractured, with remnants of the delivery regulator and filling connection fittings remaining attached to their respective lines. Close examination of all exposed connections, fittings and lines showed no evidence of heating, sooting or discolouration that might have suggested localised combustion had occurred within or in proximity to the cylinder and its connections. Similarly, all structural, panel and cargo surfaces that surrounded the fuselage rupture showed no evidence of heating or damage associated with combustion effects. The pressure gauges on all 12 remaining

Figure 7: Fuselage rupture coincident with mounting position of the number-4 oxygen cylinder

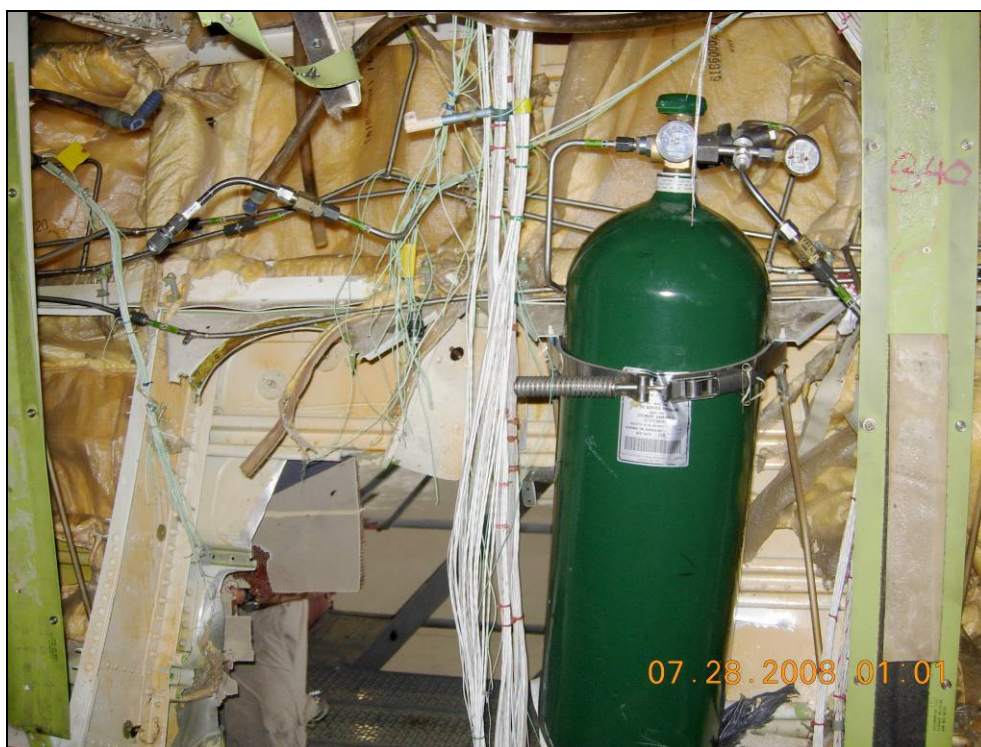
Figure 8: Number-5 oxygen cylinder adjacent to fractured fittings and lines from the number-4 cylinder

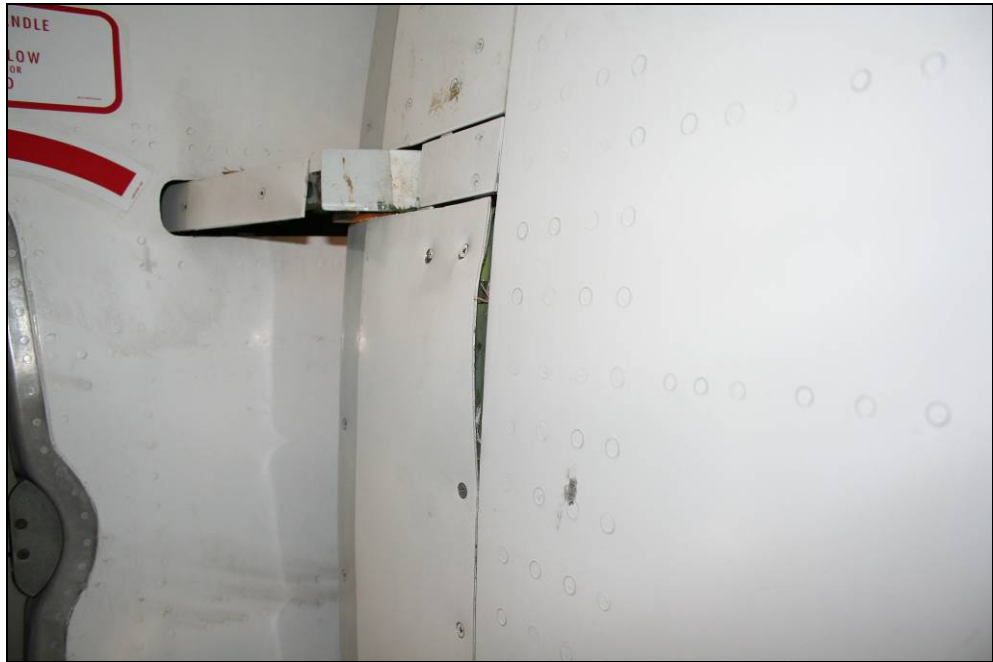
The R2⁸ door into the aircraft's main cabin was located directly above the fuselage rupture (at STA 830). An external panel located between the two door hinges showed localised outward bulging from a point immediately below the upper hinge, with the forward edge of the panel raised above the surrounding fuselage skin (Figure 9). The main external door handle was in the fully closed position, however the upper and lower door gates⁹ were partially retracted.

Figure 9: Cabin R2 door – damage to external panelling

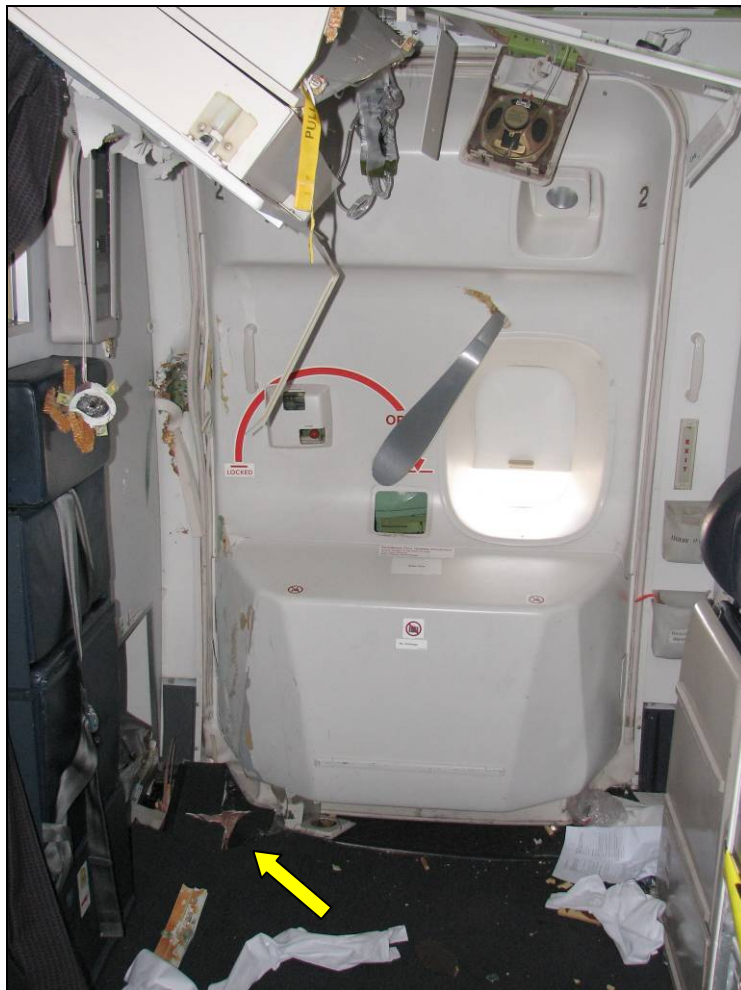
Within the aircraft, the cabin around the R2 door had sustained substantial damage and disruption (Figure 10). The cabin floor to the left and immediately inside the R2 door frame had sustained an impact that created a single circular perforation approximately 20 cm (8 inches) in diameter, located immediately above the number-4 oxygen cylinder position (Figure 11). Fragments of the cabin flooring and covering extended down into the hole. Above the hole, the forward partitioning panel between the door and the row 26J,K seats showed an elongated green coloured abrasion, leading upward to an area of impact damage at the mid-height position of the forward R2 door frame (Figure 12). The door escape slide shroud (bustle) also showed vertically-oriented scoring and green smear marks along the corner and forward facing surface. The portable walk-around oxygen cylinder normally located in an alcove just inside the R2 door was not present, and was not accounted for in a subsequent search of the aircraft.

Figure 10: Interior of R2 door and cabin – location of floor hole arrowed

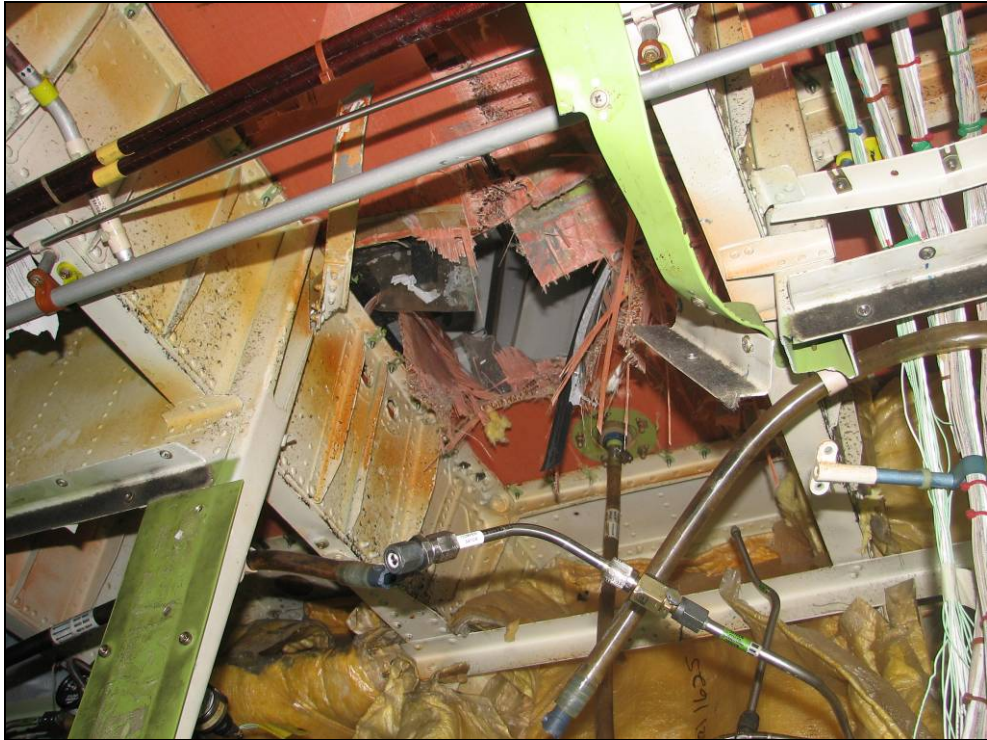
Figure 11: Hole in cabin floor – viewed from position of number-4 oxygen cylinder

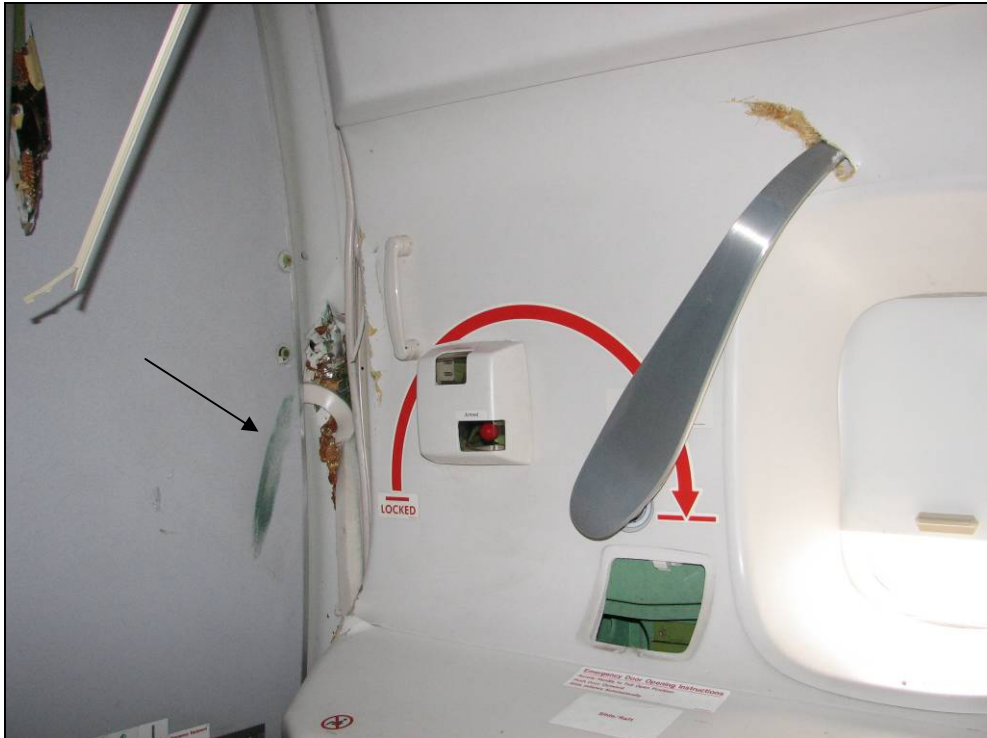
Figure 12: Door frame damage, green paint smear and rotated R2 door handle

The internal door handle was found in approximately the one-o'clock position (looking from inside), with the turned-in handle end embedded into the door lining material. That position was consistent with a movement through approximately 120 degrees from the fully-closed (locked) position. A 180 degree handle movement represented the fully open position. The downward facing surfaces of the handle end (when the door is in the locked position) showed damage and abrasion consistent with impact against another object. Inspection of the internal door systems showed the handle shaft had fractured and the actuating cam plate and retainer had pulled away from its associated mechanism (Figure 13), allowing the handle to rotate freely. As such, the handle position as observed inside the cabin was not indicative of the actual door security.

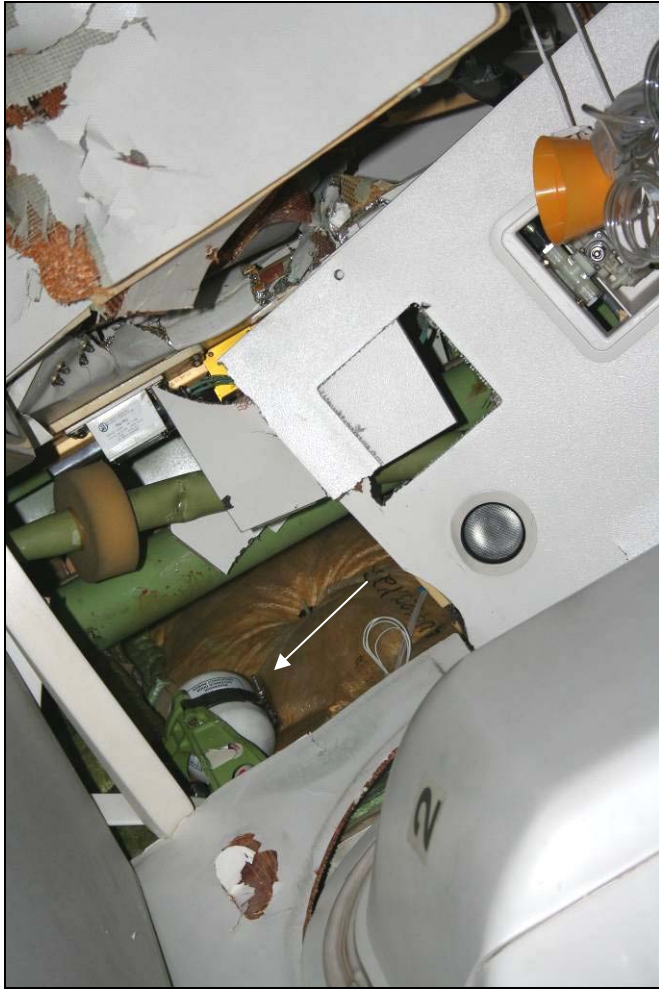
Above the R2 door within the cabin, the overhead panelling, fixtures and utility storage compartments had sustained extensive impact damage. The panels above the door frame had been pushed inward, exposing the overhead structure and pressure reservoir for the door emergency power assist opening system (EPAS, Figure 14). Amongst the impact damage, it was observed that an unusually uniform semi-circular section had been forcibly cut from the panelling and access door (Figure 15), with the cut-out section later recovered from above the damaged storage compartment casing. The diameter of the cut-out region closely matched that of the passenger oxygen cylinders (Figure 16). Adjacent to the cut-out opening was a semi-circular area of crushing damage to a partitioning panel (Figure 17); the damage being of a similar diameter to the cut-out section. A light fitting, normally present in the overhead panels had sustained upward crushing damage and presented clear green paint smears of a similar colouration to the marks on the partition panel and door bustle.

Figure 14: Damage above R2 door, exposing the EPAS cylinder (arrowed)

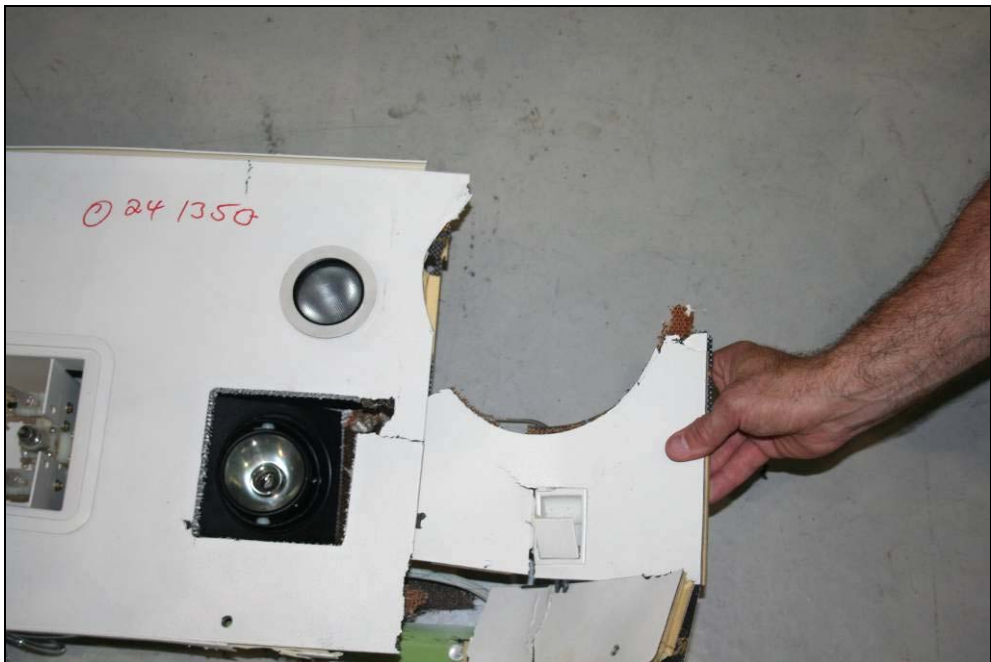
Figure 15: Cut-out section found in panels above the R2 door

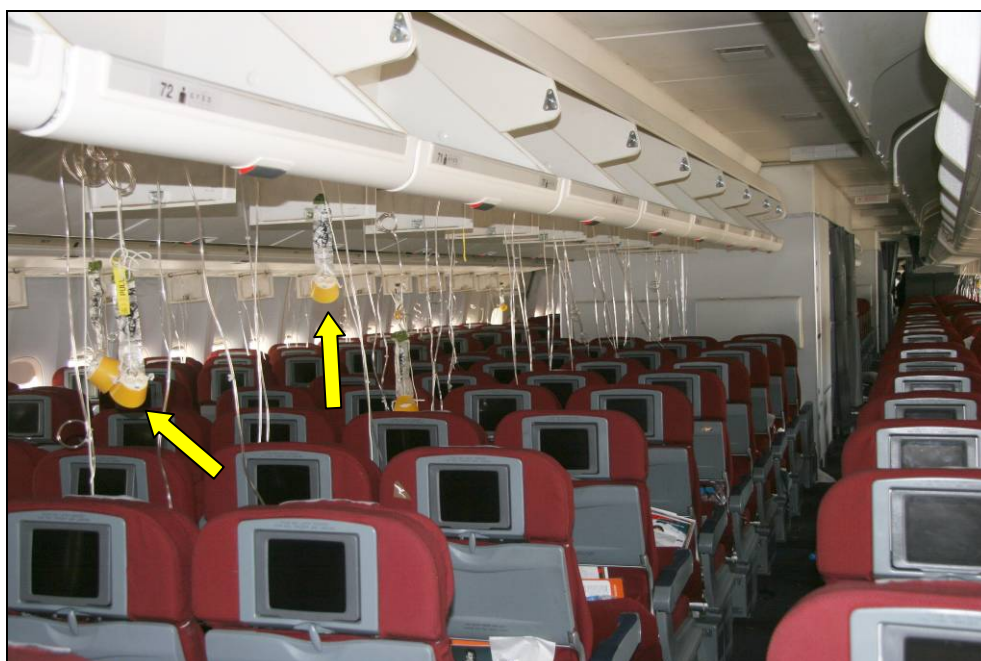
- there were 353 passenger seats in the aircraft
- 476 passenger oxygen masks had deployed from their overhead compartments
- 426 passenger oxygen masks were pulled down (i.e. activated for use)
- row 53 centre overhead passenger service unit was hanging down
- forward crew rest and customer support manager station masks had not deployed
- the covering on the rear surface of the partition in front of seats 40A,B,C was damaged
- floor pressure relief panels were open at seats 24A (2), 25A, 37K and 54A
- one mask hose was detached from the ceiling fitting at seat 4K (3 masks deployed).

Figure 18: Typical appearance of cabin. Note passenger masks dropped and activated, and those dropped and not activated (arrowed)

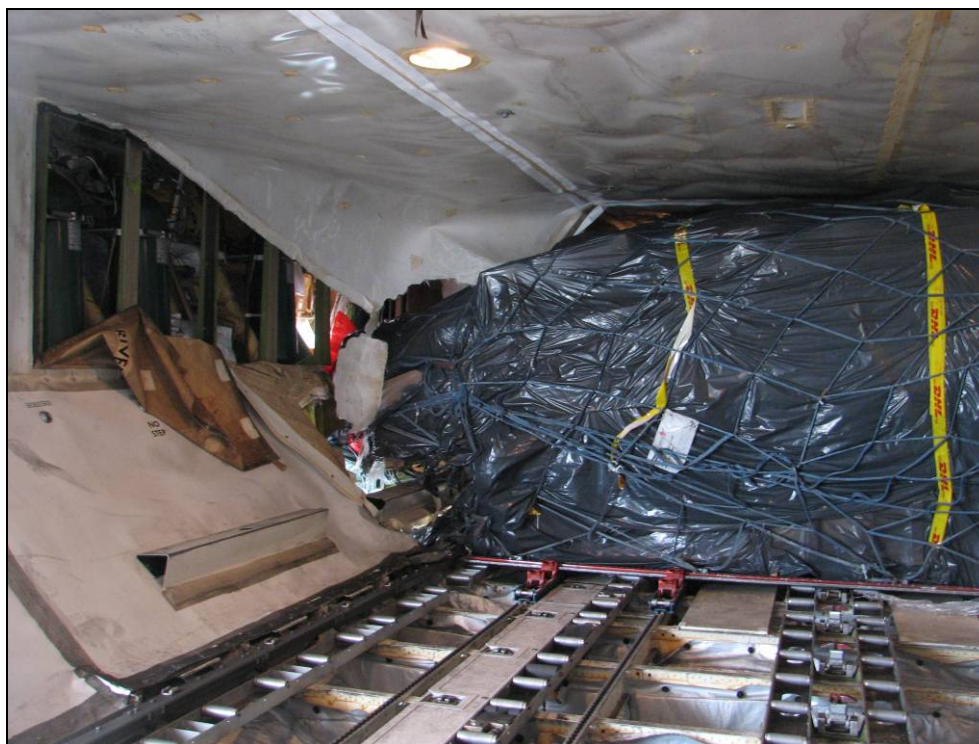
Figure 19: Cargo pallet adjacent to fuselage rupture (view looking to the rear)

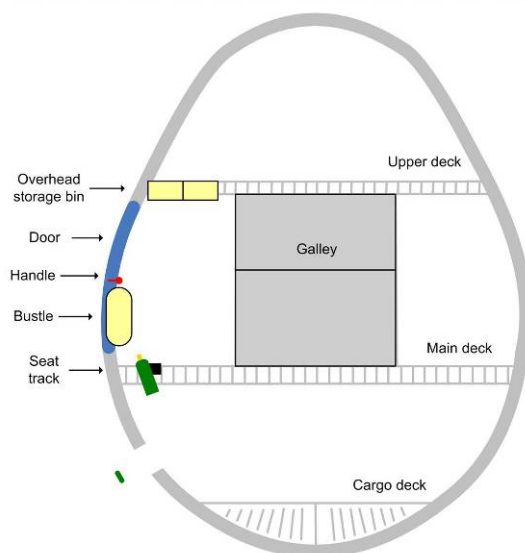
2. Cylinder failure produces fuselage rupture, with bulk of the cylinder length propelled upward through the cabin floor. See Figure 11.

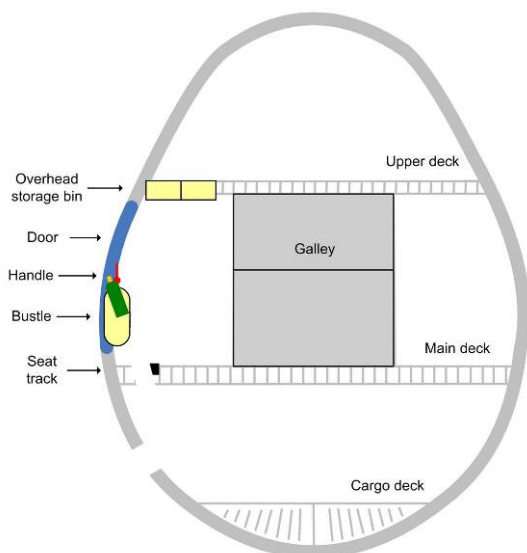
3. Cylinder impacts R2 door frame and internal door handle. See Figures 10 & 12.

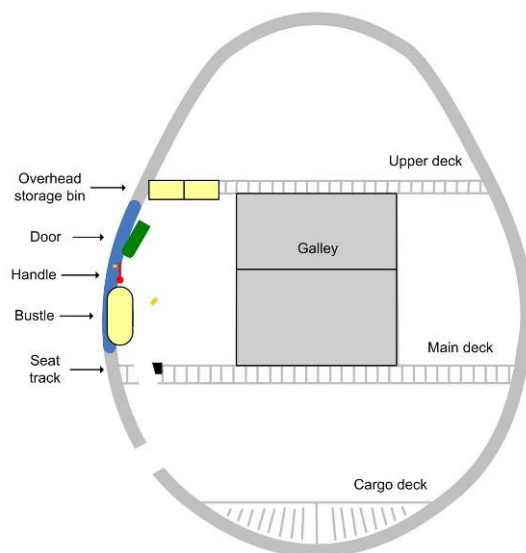
4. Door frame impact breaks off cylinder valve and causes cylinder to invert while continuing to travel upward.

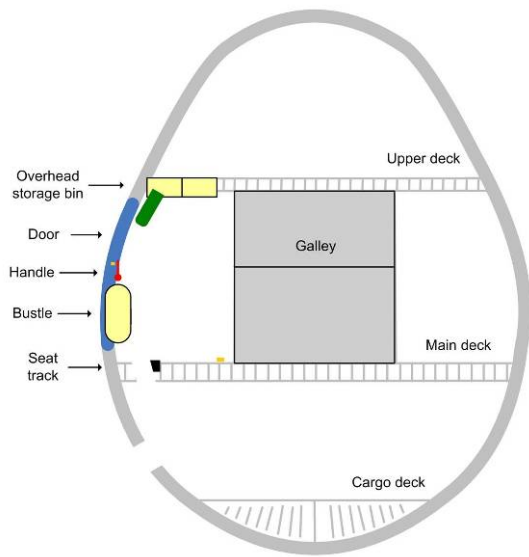
5. Cylinder impacts overhead panelling end-on, producing circular cut-out type damage. See Figures 14-16.

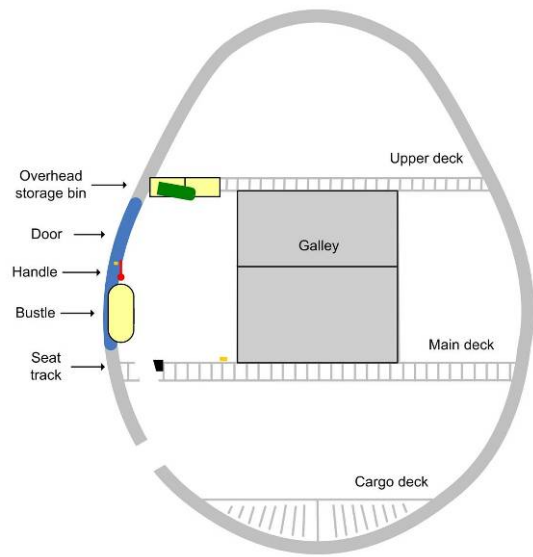
6. Still rotating cylinder impacts overhead storage bin, producing semi-circular crushing damage. See Figure 17.

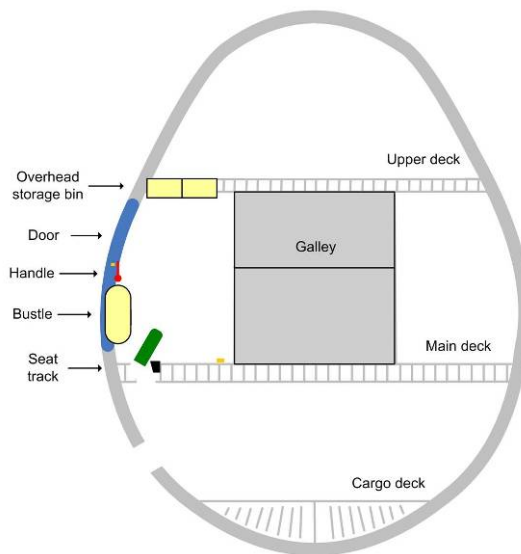
7. Cylinder falls to cabin floor and exits the aircraft through the ruptured fuselage.
