Aviation Occurrence Investigation AO-2008-053

Preliminary

**Depressurisation
475 km north-west of Manila, Philippines
25 July 2008
Boeing Company 747-438, VH-OJK**

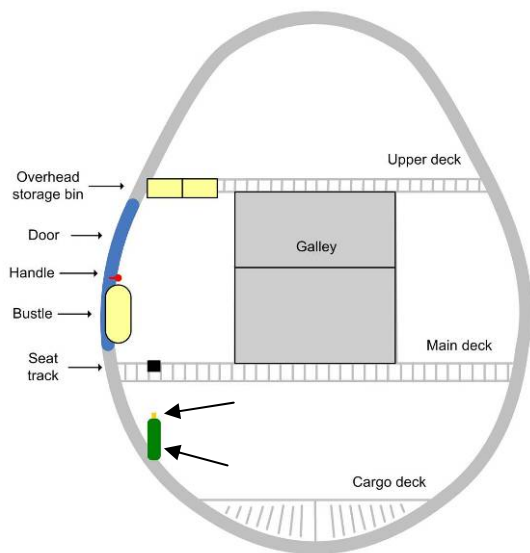
1. Normal arrangement (Oxygen cylinder and valve arrowed)

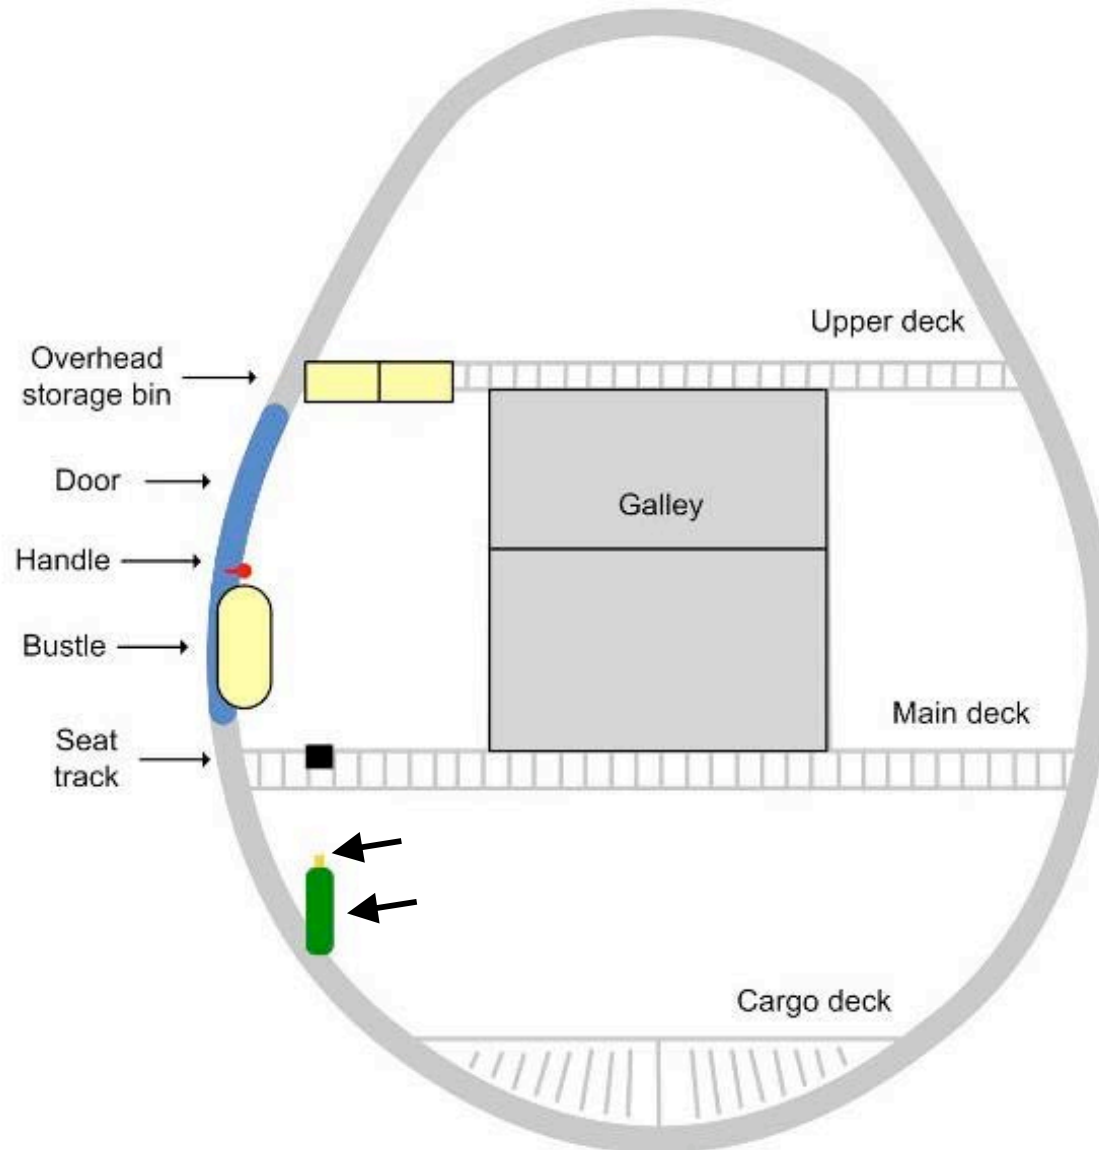
2. Cylinder failure produces fuselage rupture, with bulk of the cylinder length propelled upward through the cabin floor. See Figure 11.

2. Cylinder failure produces fuselage rupture, with bulk of the cylinder length propelled upward through the cabin floor.

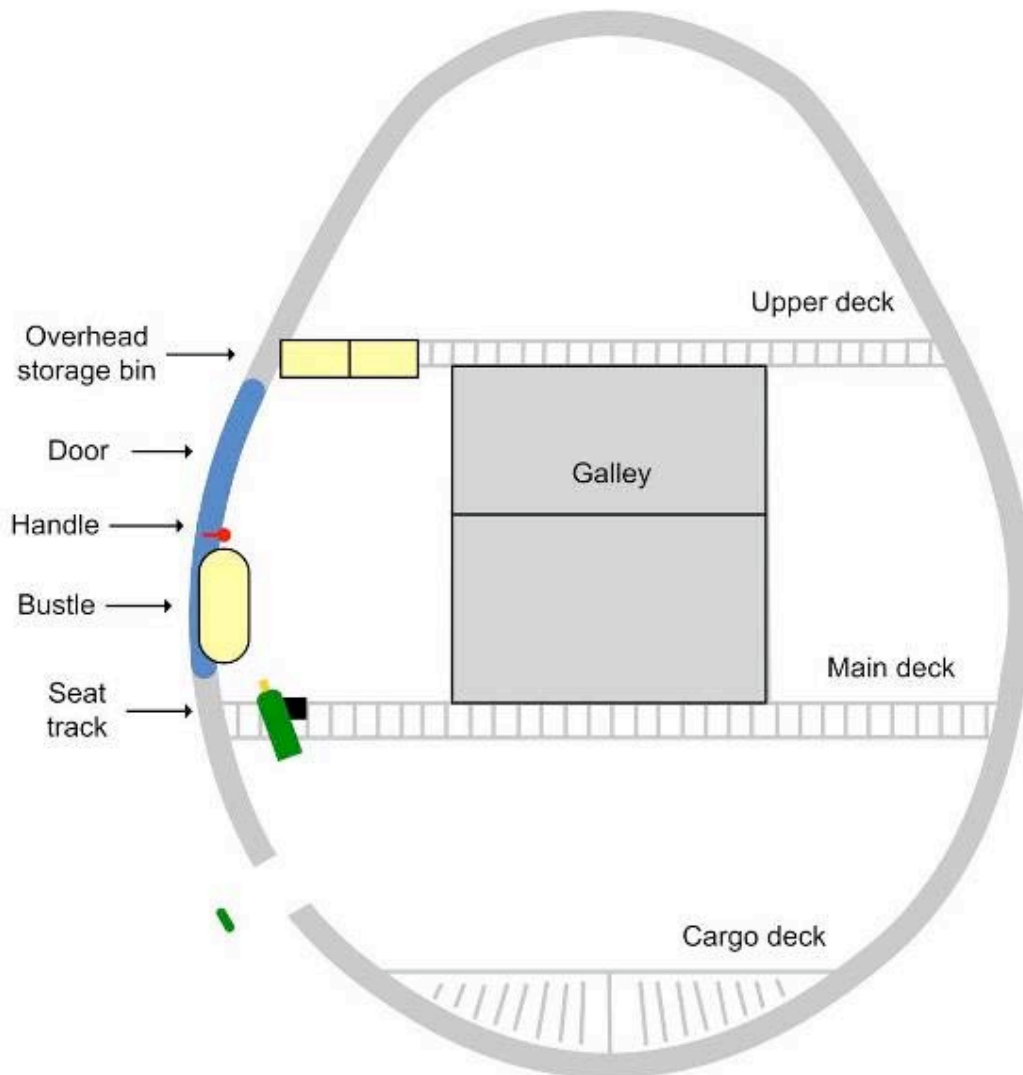
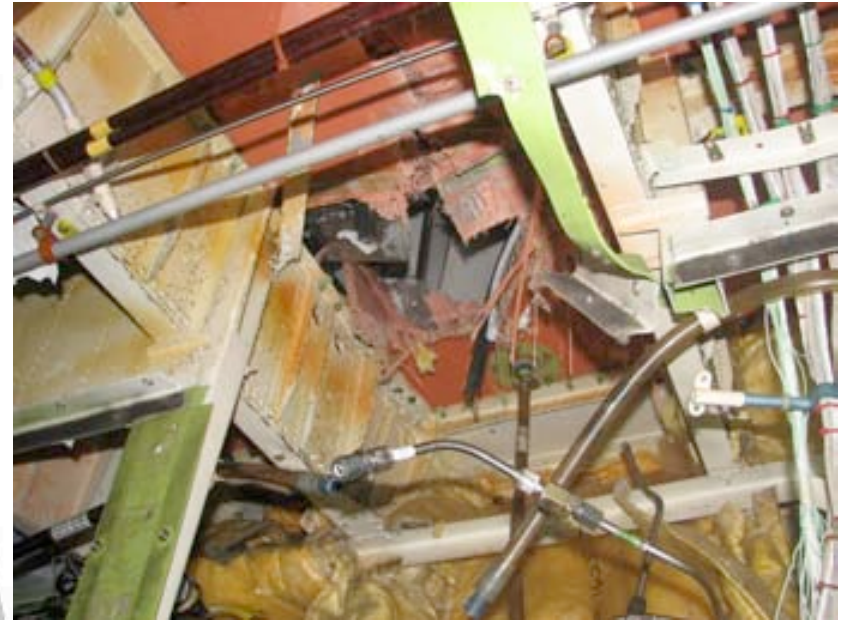
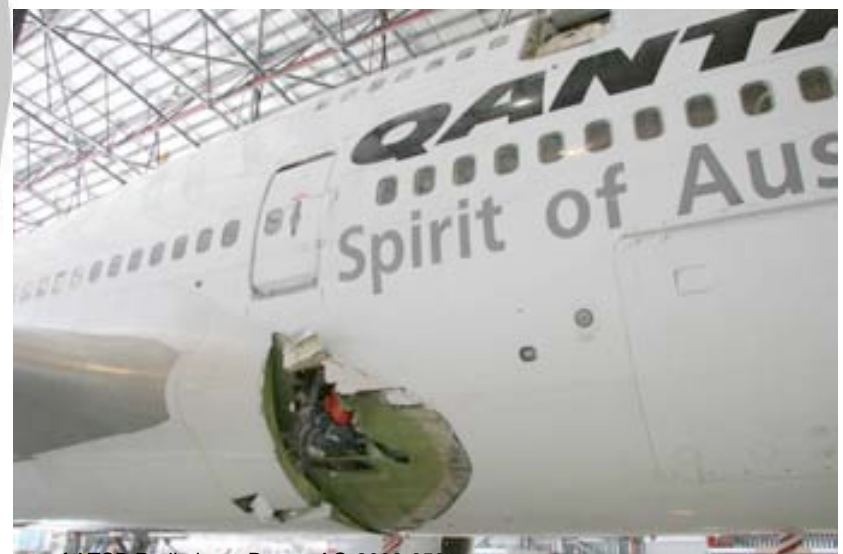
3. Cylinder impacts R2 door frame and internal door handle.

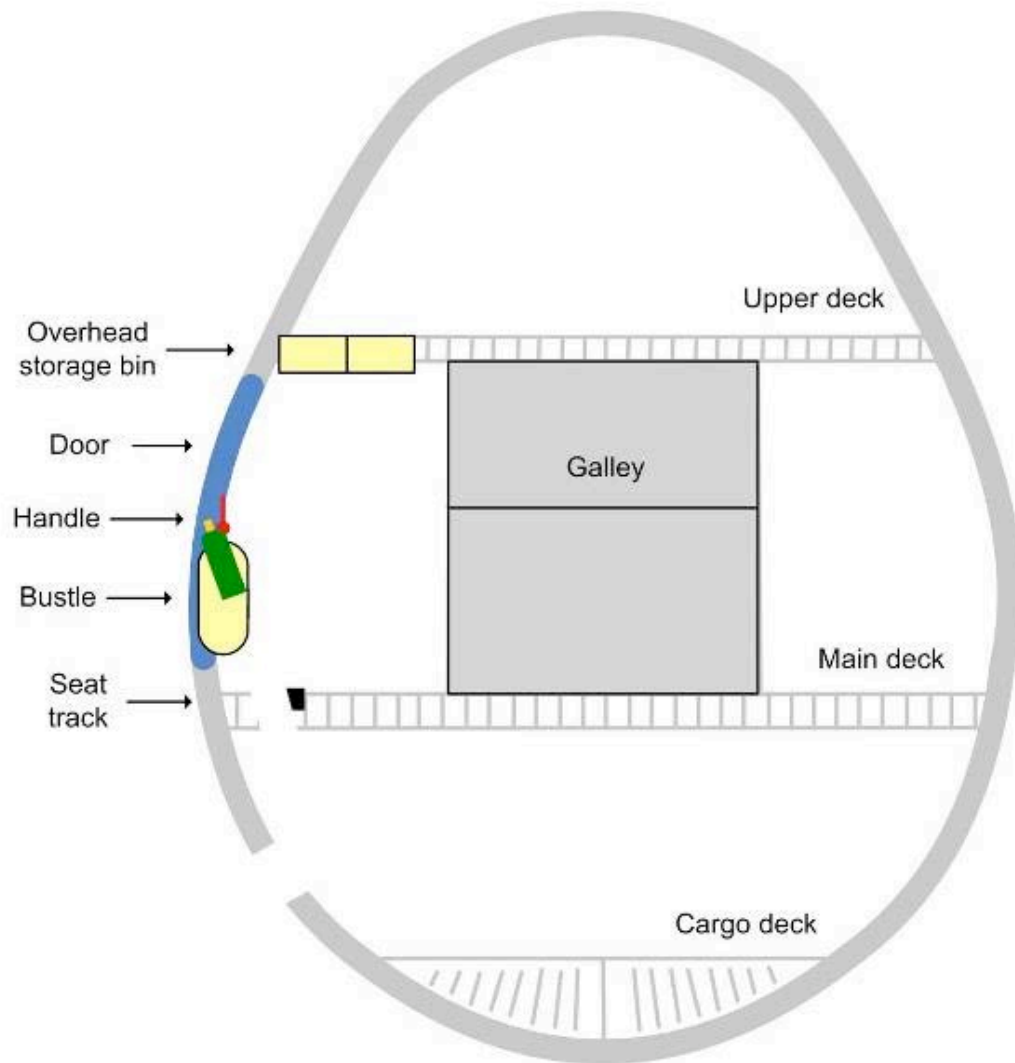
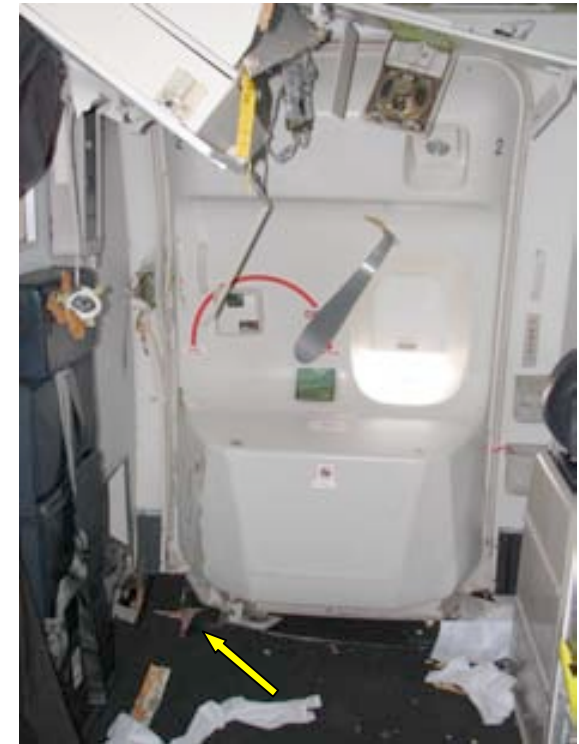
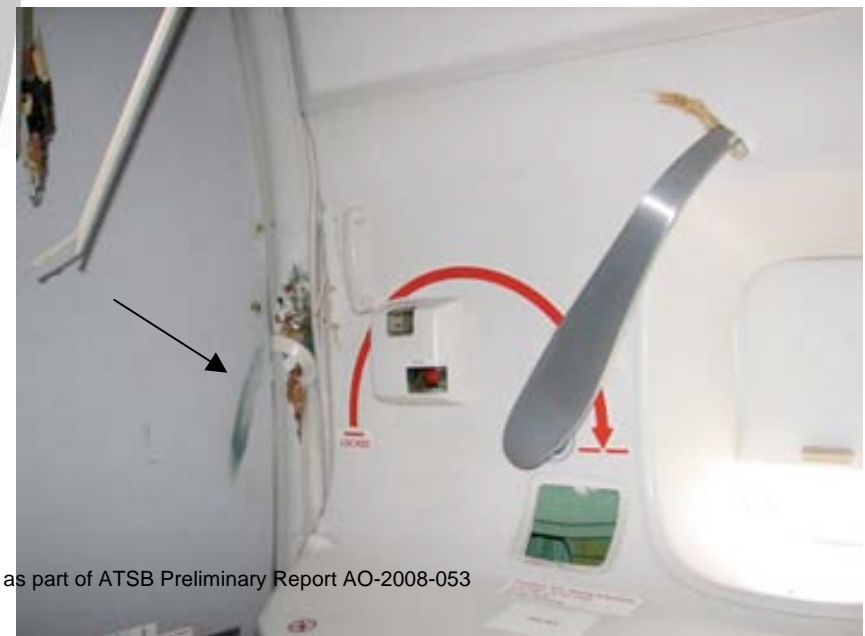
4. Door frame impact breaks off cylinder valve and causes cylinder to invert while continuing to travel upward.

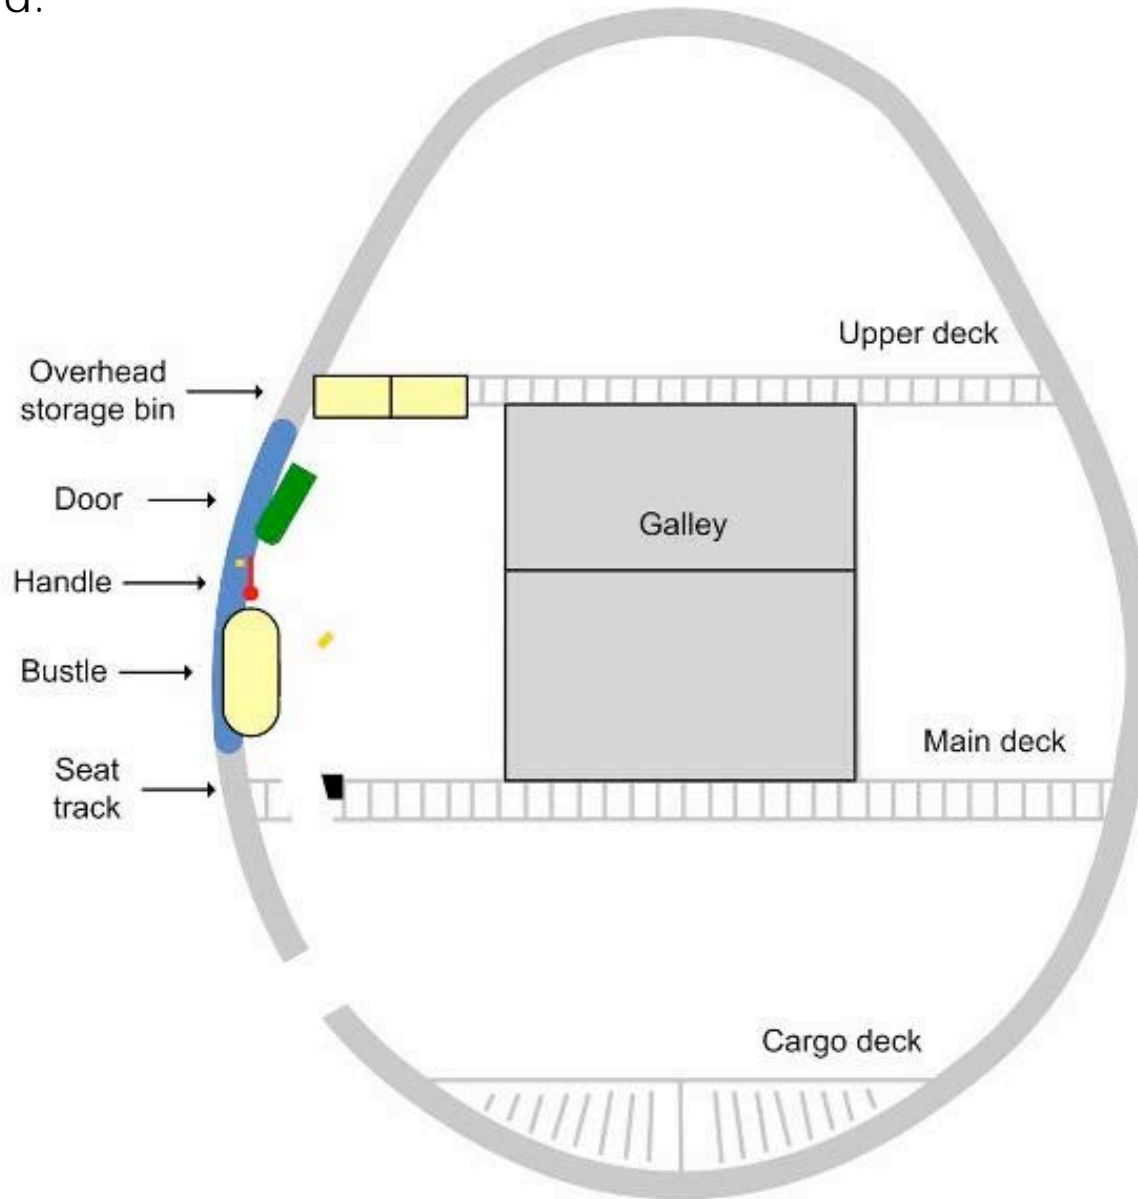
5. Cylinder impacts overhead panelling end-on, producing circular cut-out type damage. See Figures 14-16.

5. Cylinder impacts overhead panelling end-on, producing circular cut-out type damage.

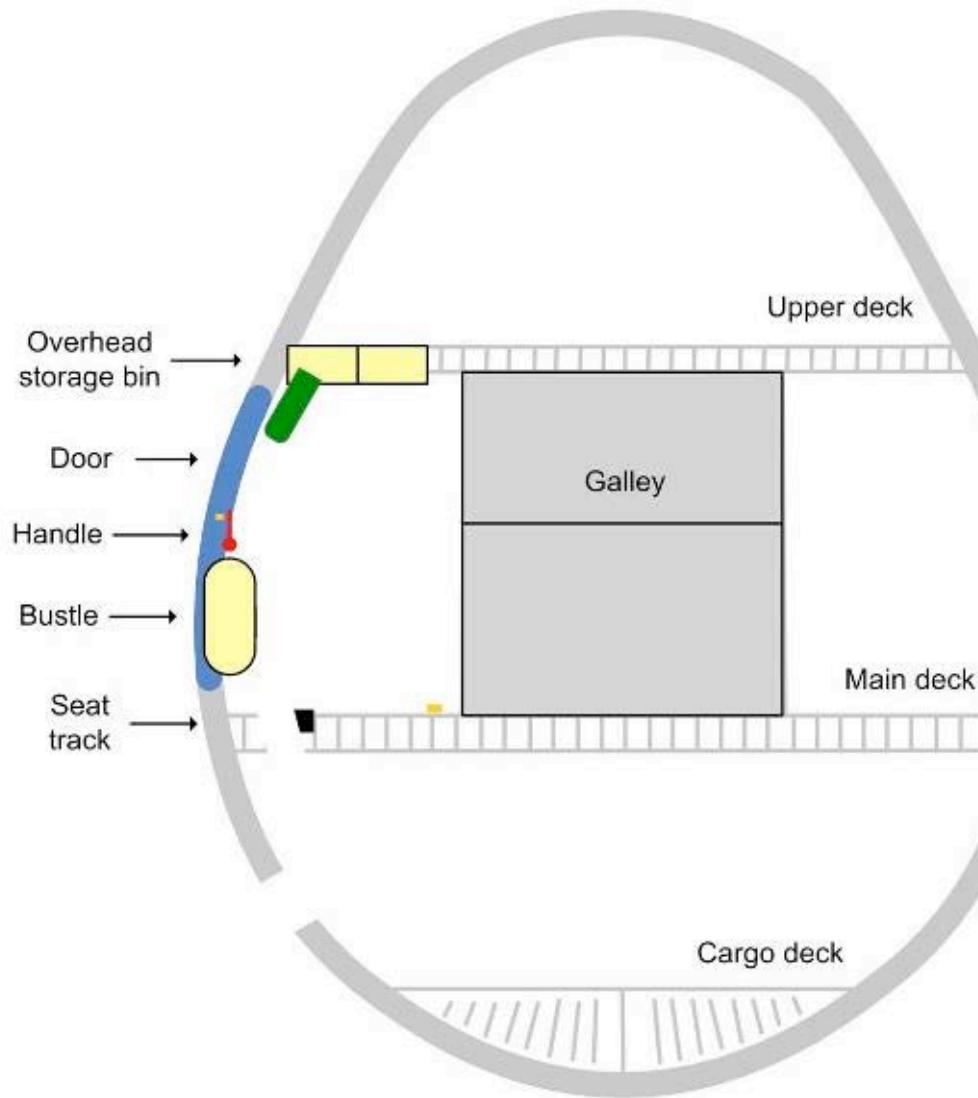
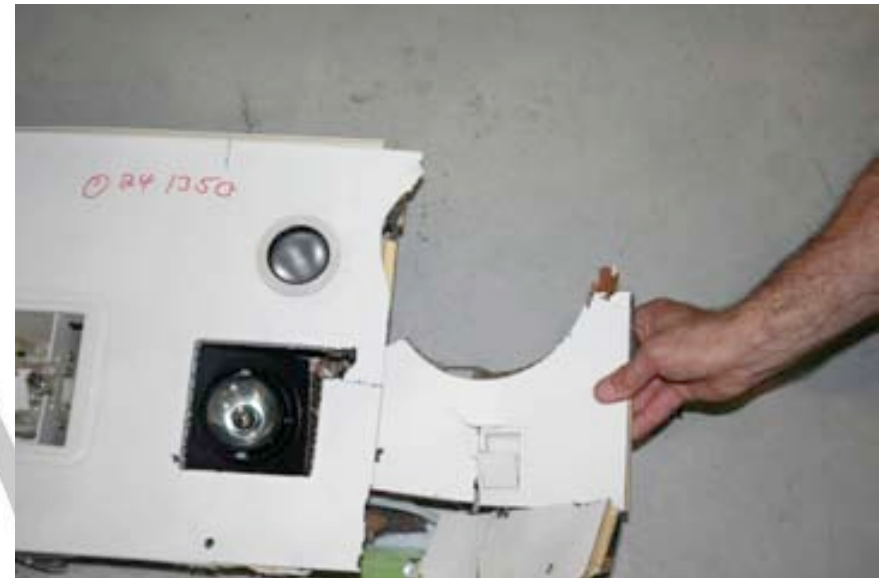
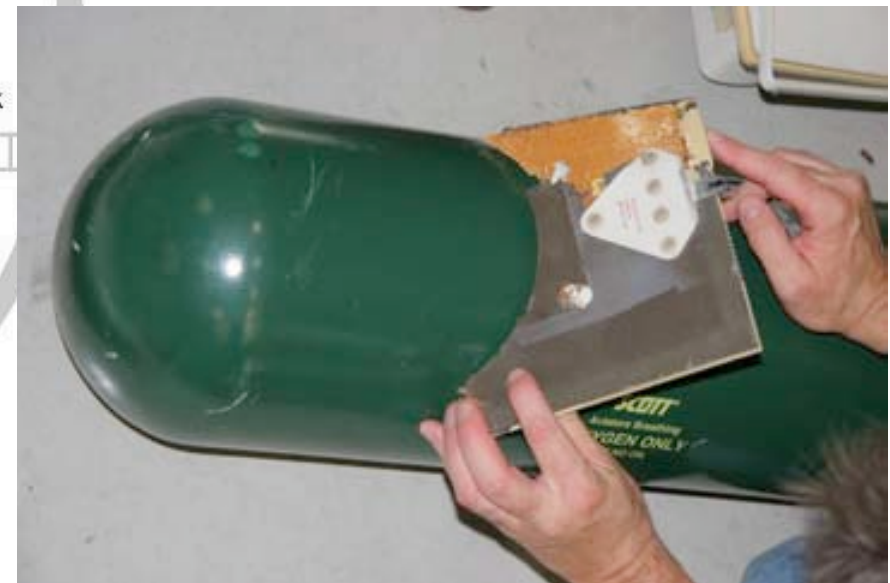
6. Still rotating cylinder impacts overhead storage bin, producing semi-circular crushing damage. See Figure 17.

6. Still rotating cylinder impacts overhead storage bin, producing semi-circular crushing damage.

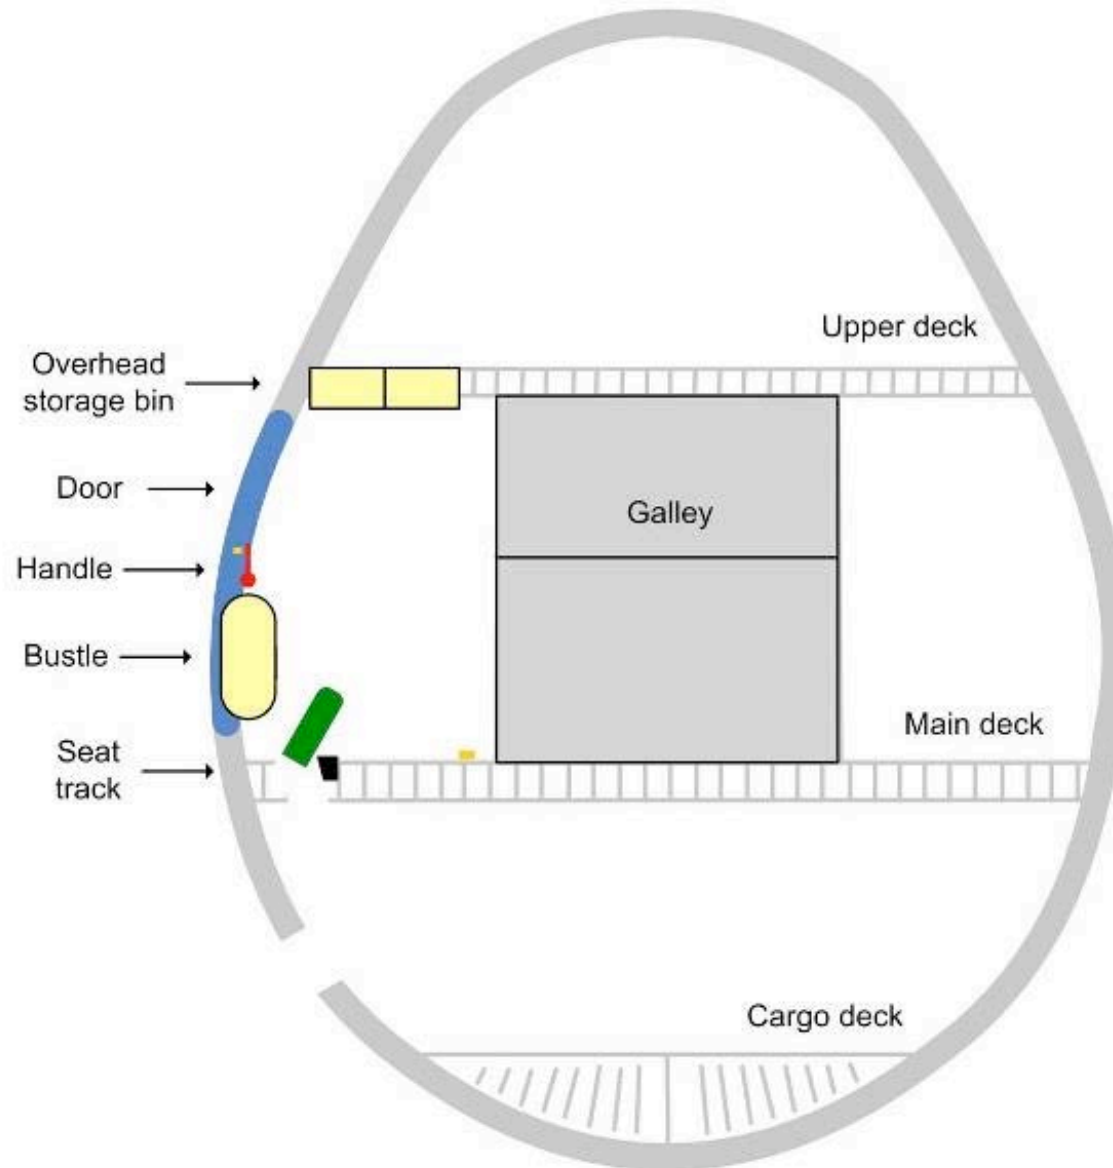
7. Cylinder falls to cabin floor and exits the aircraft through the ruptured fuselage.

7. Cylinder falls to cabin floor and exits the aircraft through the ruptured fuselage .
